# Manhole Inspection Summary

Manhole # S33QQ\_101MH

Insp Date: **10/28/08 3:32 PM**

**Location** Address: **2515 HOWARD ST**

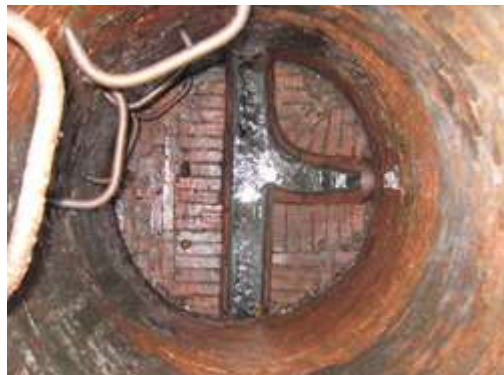
Top View

Bench and Channel debris.

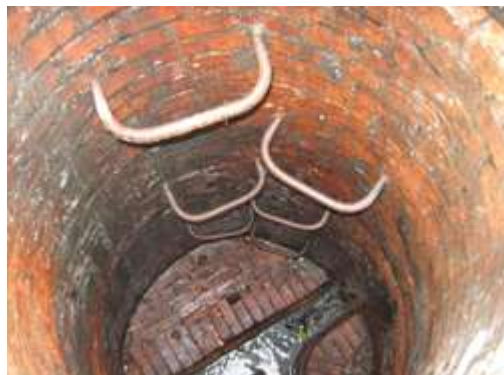
Defect

Frame leaks. Adjustment, Corbel and Barrel infiltration - other side.

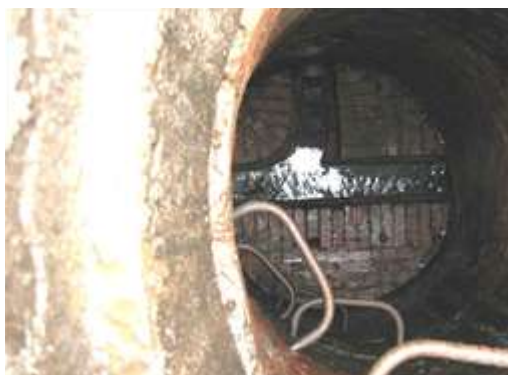
Defect

Frame leaks. Frame offset.

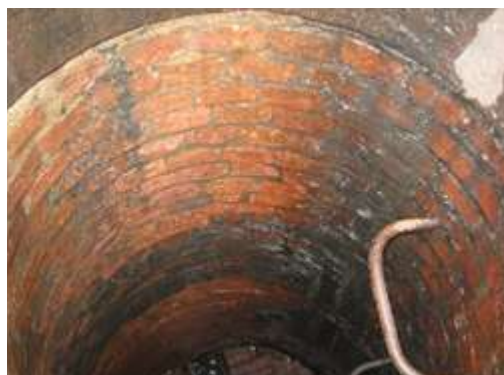
Defect

Frame leaks. Adjustment, Corbel and Barrel infiltration.

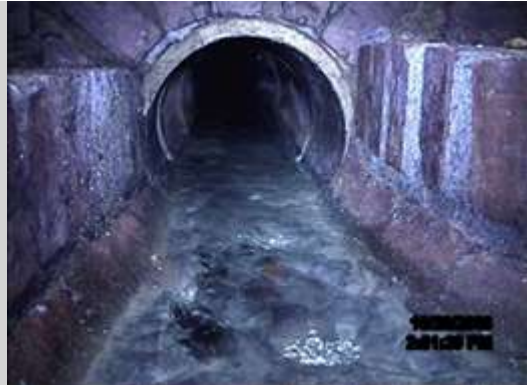
### 8 in. Circular Gravity Sewer Pipe Out @ 12 O'Clock

Infiltration: **Evidence** Pipe Seal Cond: **Unknown**
